WATER QUALITY MEMORANDUM

Utah Coal Regulatory Program

RE: 2010 First Quarter Water Monitoring, Genwal Resources, Inc., Crandall Canyon Mine, Permit & Tracking #3473

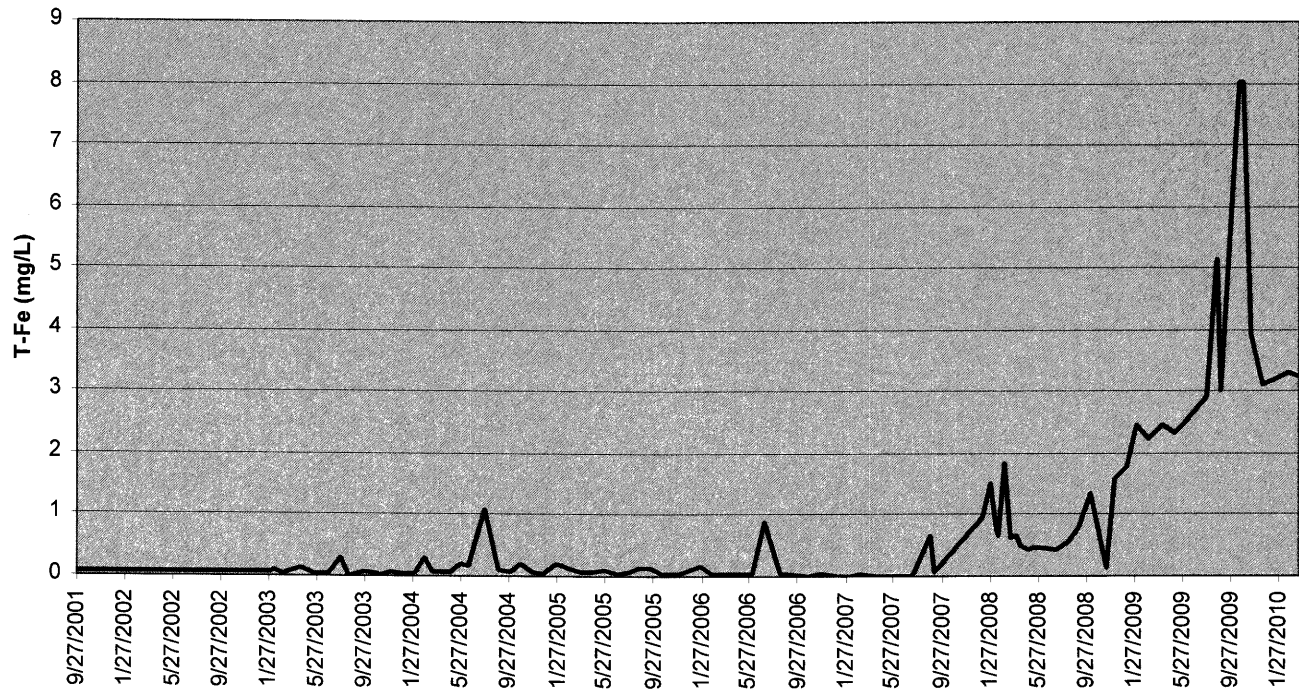
Total Iron (T-Fe): Outfall 002

Outfall 002 reported an average flow of 428.3 gpm for the quarter. T-Fe concentrations continue to remain elevated. All three sampling events conducted this quarter produced T-Fe levels above the UPDES limit of 1.0 ppm (3.2 ppm, 3.3 ppm and 3.23 ppm respectively for January, February and March).

Continued data collection and monitoring of the mine-water discharge will be necessary to evaluate the effectiveness of the mine-water treatment system. Monitoring of the pre-treatment mine-water will help determine the overall chemistry of the raw mine-water.

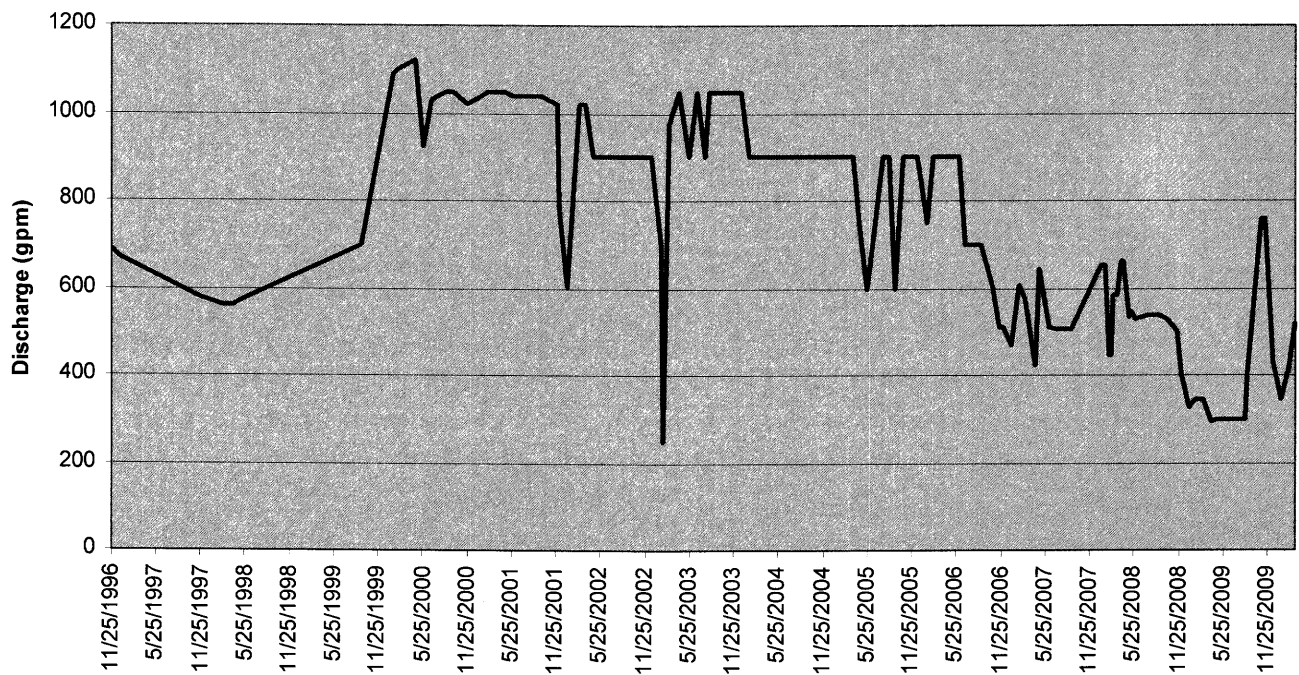
Mine Water Discharge (Outfall 002)

The Permittee has completed construction of the mine-water discharge treatment system. Final approval for the treatment system was granted by the Division on January 27th, 2010. The mine-water treatment system utilizes a Maelstrom oxidizer unit, a coagulant and flocculent injection system and settling basin.

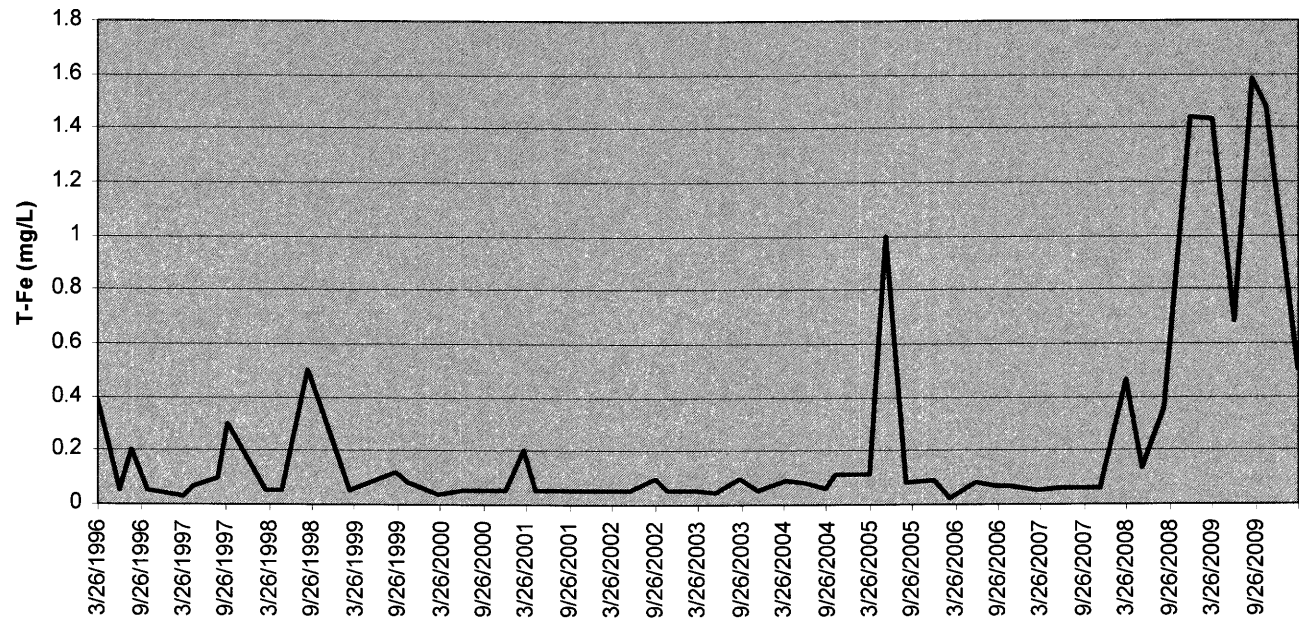
Crandall Creek Lower Flume (LOF-1): Total Iron Levels

As the total iron (T-Fe) concentrations in the mine-water discharge have increased, a similar rise has been observed in stream monitoring site LOF-1 (lower Crandall Canyon flume). An upward trend of T-Fe began to surface the second quarter of 2008. There have been fluctuations, but the overall trend has been upward. Last quarter's reported T-Fe value at LOF-1 was 1.479 mg/L. However, this quarter's reported value was 0.503 mg/L. Continued monitoring will be conducted in order to ascertain a relationship between the T-Fe concentrations in the mine-water discharge and the receiving stream.

Work with other regulatory agencies in determining what if anything can be done to remove or mitigate the iron staining within the Crandall Creek stream channel (See Photos Below).
